CERRILLOS

Site Description and Monitoring Activities

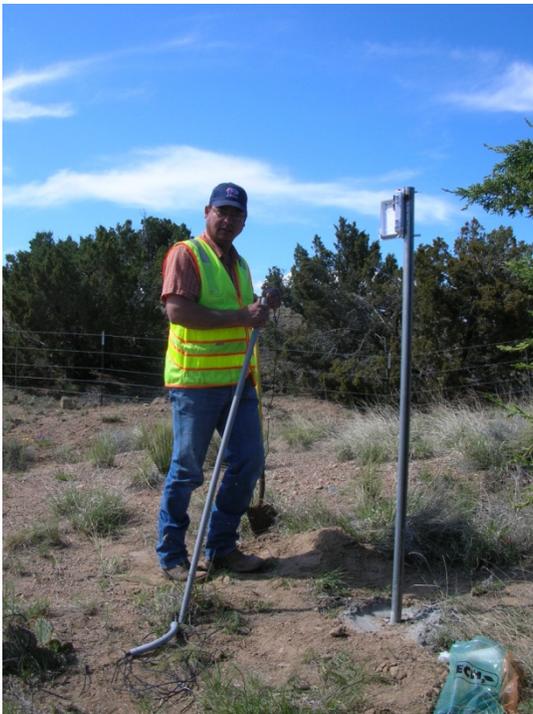
Figure 1. DOT employee assisting with sensor installation

Due to the increasing use of wood mulch for post-construction erosion mitigation and revegetation, information from the DOT locations has potentially far-reaching implications. Four soil moisture probes, four soil temperature probes, and a rain gauge were installed within the NMDOT right-of-way in May, 2007 in the pattern described previously (Figure 1). Equipment positions were finalized in July 2007. Vegetation was measured in early November, 2007 using a square meter quadrat placed randomly within untreated and mulched areas (Figure 2). Vegetation measurements included percent cover and frequency data.

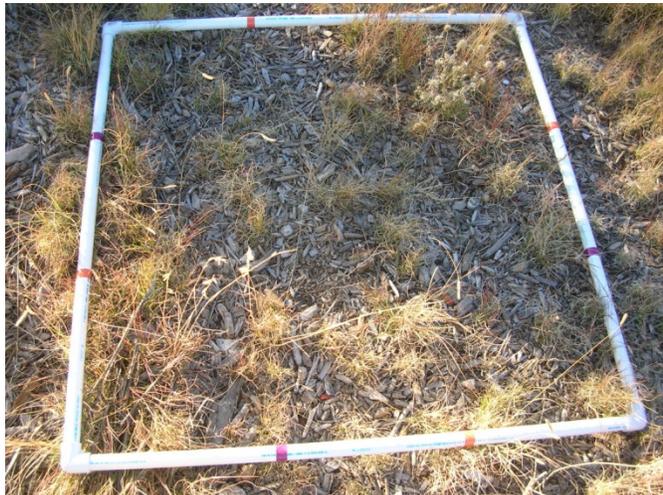
Figure 2. Vegetation quadrat

Vegetation measurements were intended to determine whether 70% cover had been achieved in the treated areas. Percent cover between treated and adjacent untreated areas were almost equal, indicating exceedance of the 70% goal. The average cover within treated areas was 26% versus 27% in untreated, bare soil quadrats.

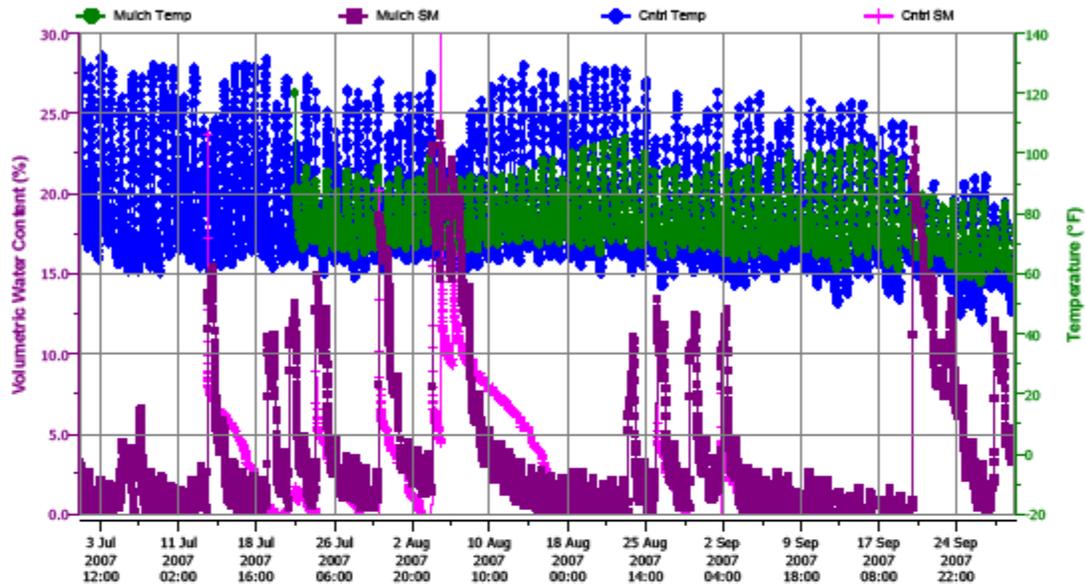
Figure 3. DOT1 Data Logger, Summer 2007

P1	P2	P3	P4
	°F	%	°F	%
Avg:	75.91	3.75	81.01	-0.25
Min:	56.7	-1.6	44.3	-6.5
Max:	120.1	24.3	132.8	46
Total:	---	---	---	---
Events:	---	---	---	---

Graphical summaries of data from the DOT1 and DOT2 data loggers are presented in Figures 3-10.

Readings from the temperature sensors under mulch at DOT1 and DOT2 indicate that significant thermal insulation was provided by the mulch cover. During the fall and winter from October to early March, the temperature under the mulch was generally higher. Once temperatures warmed up around the end of March, the temperature under the mulch was consistently lower and less variable. In spring 2008 (Figure 6), the temperature differences between the mulch and the control sensors at DOT1 became more pronounced as the weather warmed. The temperature under the mulch was significantly cooler and less variable. As indicated in the data summary table for Figure 6, during that quarter the maximum temperature for the mulched sensor was 107.9°F versus a maximum of 143°F measured by the control sensor.

Soil moisture measurements at the DOT1 data logger did not show expected results. The soil moisture sensor under the mulch showed wide fluctuations while the control sensor was more stable. There were some differences in microtopography but they do not explain the large fluctuations. The mulch sensor was on a slight south aspect relative to the control sensor due to the areas of mulch application. The minimum and maximum soil moisture values do not correspond with expected periods during each day. The erratic pattern of the mulch sensor readings indicate that there may be a problem with the soil moisture sensor such as poor soil contact. One of the challenges of placing the sensors close to the soil surface at this site was due to the method of mulch application during the treatment. According to DOT protocol, the wood mulch was applied with pressure and mixed with the surface soil. As a result there is no distinct line between the soil and mulch interface. Care was taken to ensure that no wood remained in contact with the sensor but it is possible that soil contact may not be optimal. The sensor should be repositioned and evaluated.

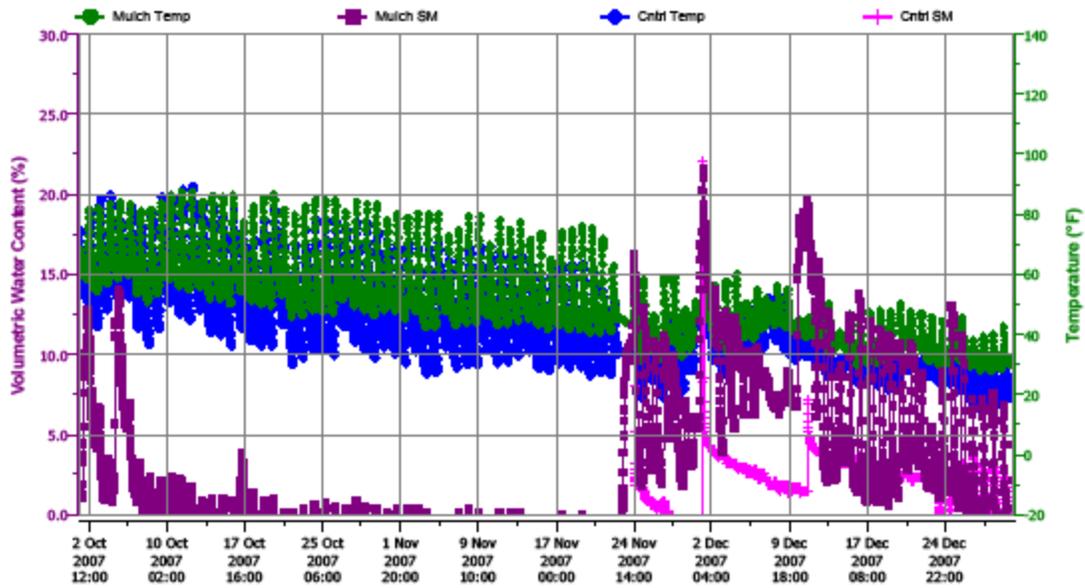
Figure 4. DOT1 Data Logger, Fall 2007

P1	P2	P3	P4
	°F	%	°F	%
Avg:	50.15	2.45	41.87	-3.23
Min:	27.6	-2.8	14.9	-7.8
Max:	87.5	21.5	89.1	22
Total:	---	---	---	---
Events:	---	---	---	---

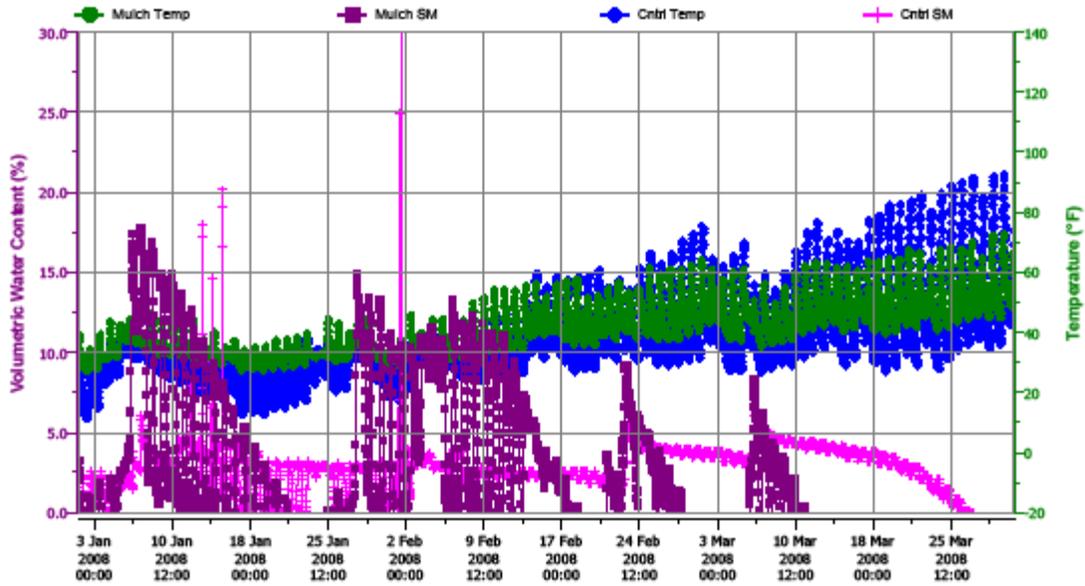
Figure 5. DOT1 Data Logger, Winter 2008

P1	P2	P3	P4
	°F	%	°F	%
Avg:	40.99	0.05	36.86	2.65
Min:	26.8	-8	11.3	-1.9
Max:	72.7	17.8	92.2	59.4
Total:	---	---	---	---
Events:	---	---	---	---

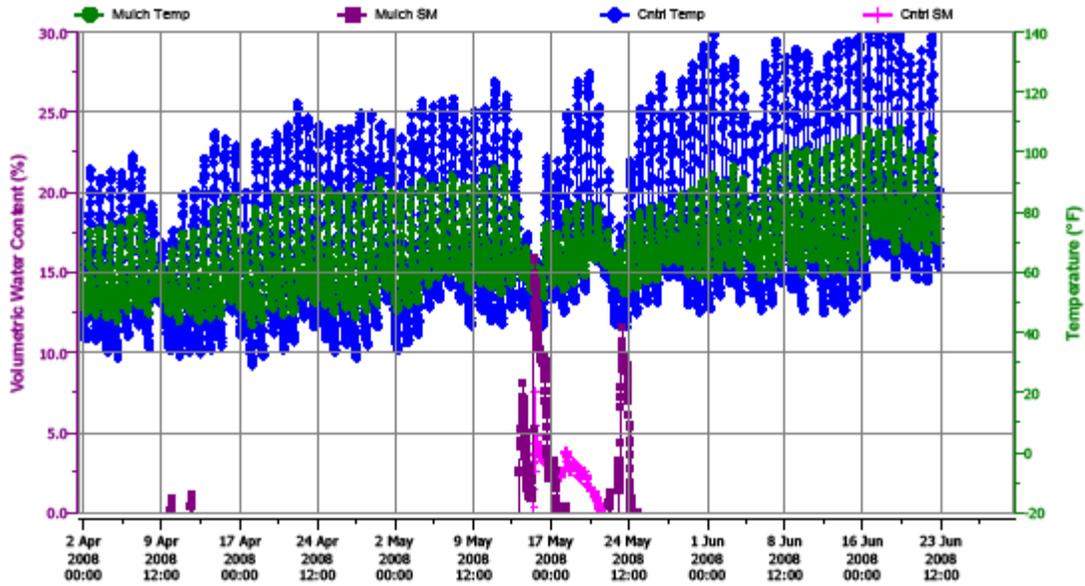
Figure 6. DOT1 Data Logger, Spring 2008

P1	P2	P3	P4
	°F	%	°F	%
Avg:	65.79	-5.59	72.13	-4.34
Min:	42.3	-8.4	29	-7.5
Max:	107.9	15.8	143	7.6
Total:	---	---	---	---
Events:	---	---	---	---

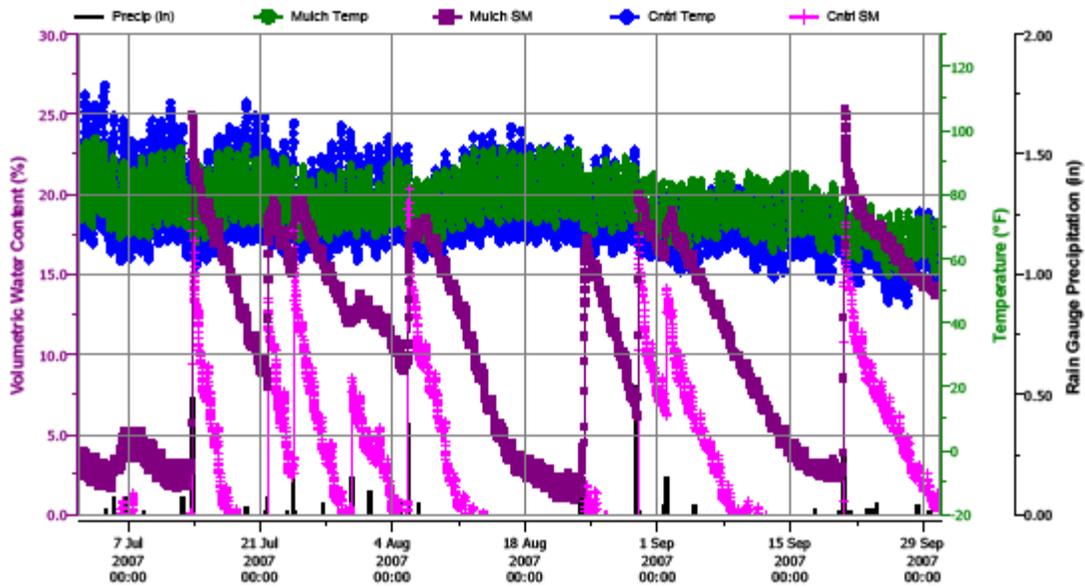
Figure 7. DOT2 Data Logger, Summer 2007

P1	P2	P3	P4	P5
	in	°F	%	°F	%
Avg:	—	76.15	10.74	74.22	2.15
Min:	—	54	0.9	45.8	-3.5
Max:	—	97.3	25.3	114.1	20.4
Total:	5.2	—	—	—	—
Events:	84	—	—	—	—

The soil moisture sensors attached to the DOT2 data logger showed patterns that would be expected based on other monitoring sites and published literature. The soil moisture was consistently higher and more persistent under the mulch than the adjacent control sensor (Figure 7-10). The difference between the mulch and control sensors was somewhat moderated by the fact that the control sensors at that location received afternoon shade while the control sensors did not. In terms of revegetation, the control soil moisture was frequently below 5-10% which is within the range of the permanent wilting point for many soil texture classes. Because the soil texture was not evaluated at this site the permanent wilting point cannot be determined exactly but overall, the bare soil areas showed values that indicate a moisture-limited environment.

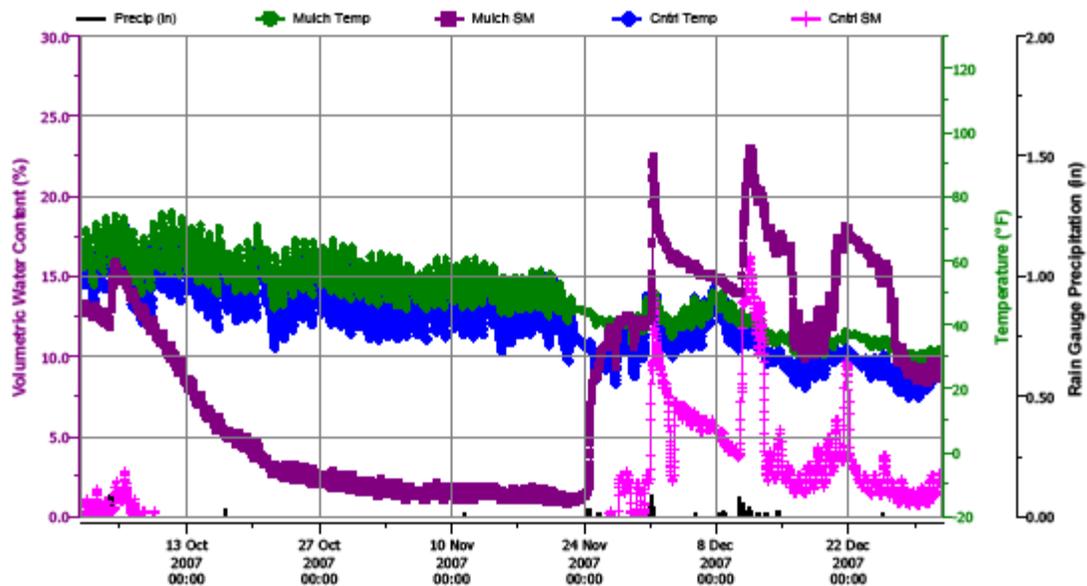
Figure 8. DOT2 Data Logger, Fall 2007

P1	P2	P3	P4	P5
	in	°F	%	°F	%
Avg:	—	47.78	8.39	41.38	0.34
Min:	—	26.9	0.7	16.9	-3.4
Max:	—	74.5	23	70.6	16.2
Total:	1.84	—	—	—	—
Events:	91	—	—	—	—

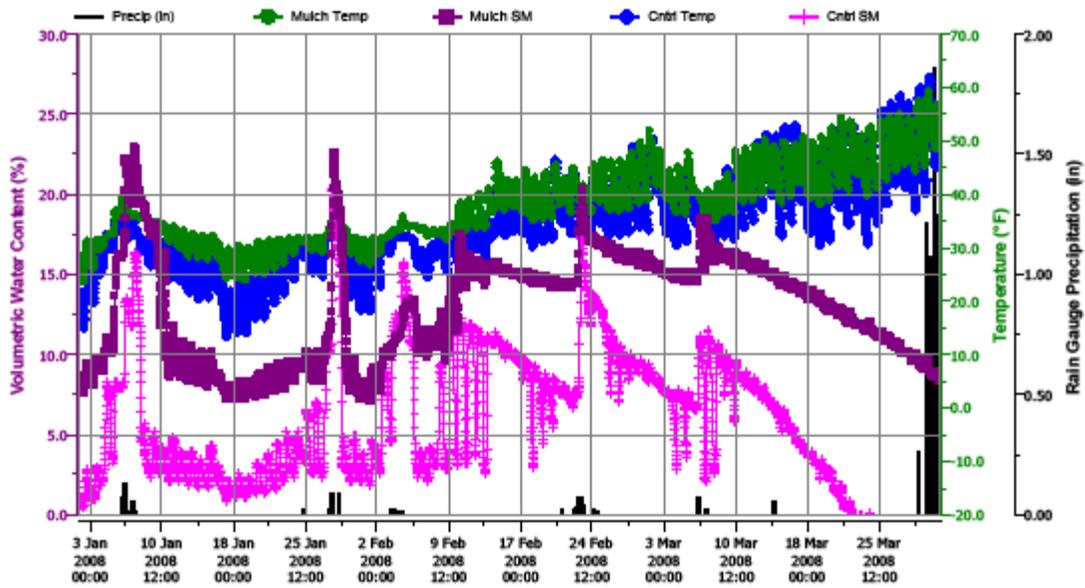
Figure 9. DOT2 Data Logger, Winter 2008

P1	P2	P3	P4	P5
	in	°F	%	°F	%
Avg:	—	37.78	12.81	34.24	5.56
Min:	—	23.6	7.1	13.2	-2.9
Max:	—	59.3	23	62	20.3
Total:	18.12	—	—	—	—
Events:	128	—	—	—	—

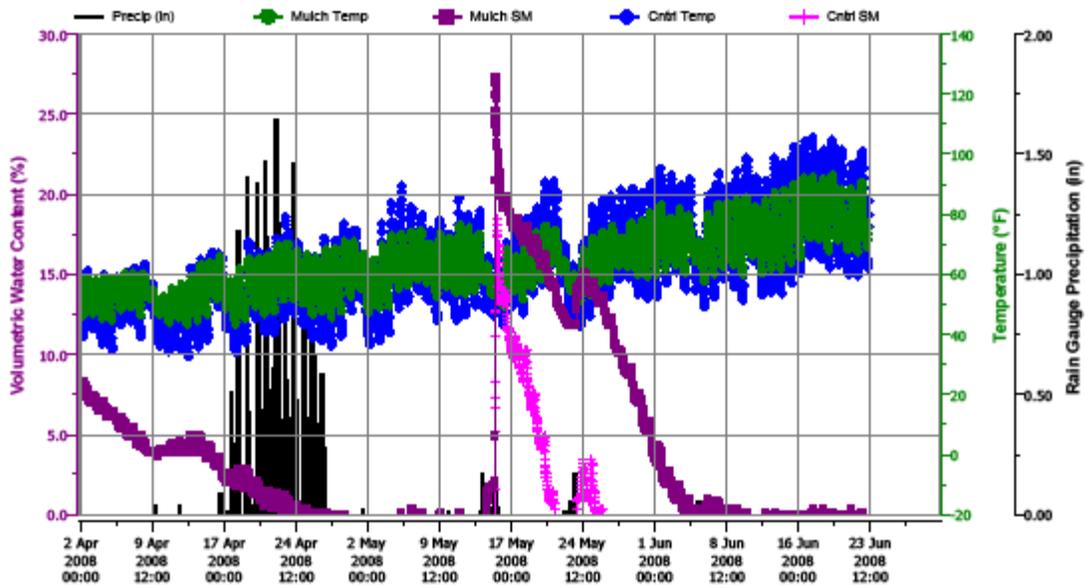
Figure 10. DOT2 Data Logger, Spring 2008

P1	P2	P3	P4	P5
	in	°F	%	°F	%
Avg:	---	62.97	3.58	62.92	-2.83
Min:	---	43	-1.5	32.8	-5.9
Max:	---	93.2	27.3	105.7	18.5
Total:	67.5	---	---	---	---
Events:	241	---	---	---	---

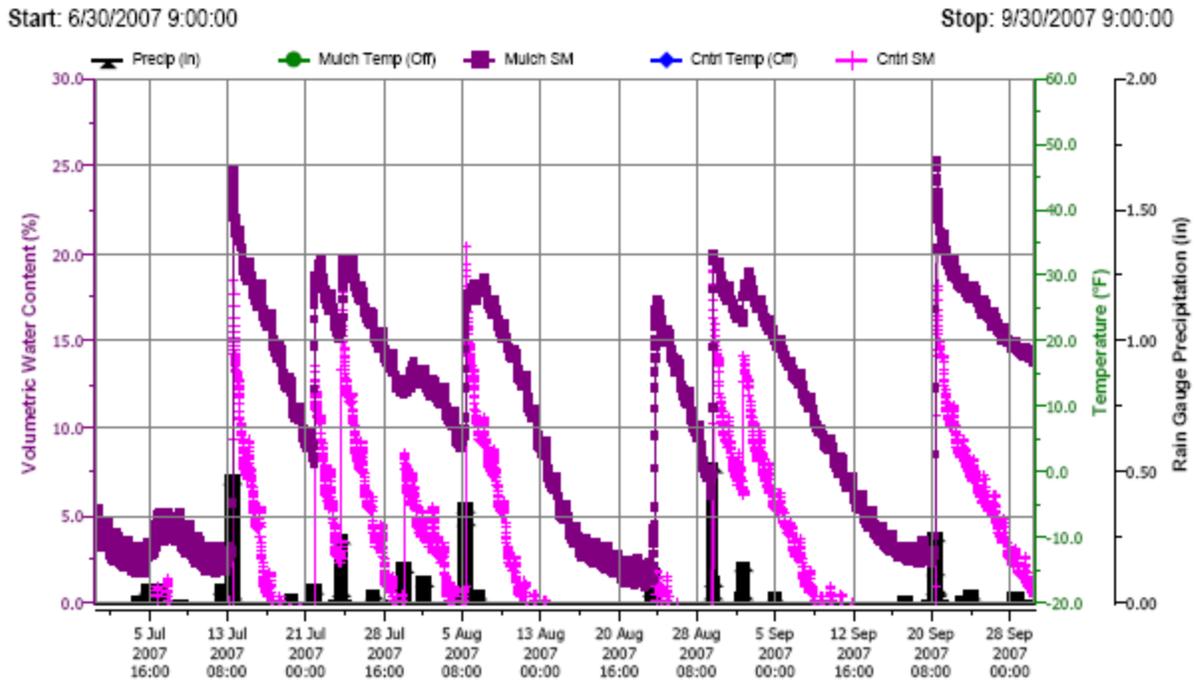
Figure 11. Close-up of DOT2 Data showing soil moisture responses to precipitation

Overall, the precipitation data was helpful in assessing the localized weather conditions at the site. Particularly monsoonal storms can be very limited in geographic extent and weather data from nearby stations in Santa Fe may not adequately reflect weather patterns at the site. However, two periods of precipitation data should be disregarded. From March 29 to 31, 2008 and from April 16 to 27, 2008, there are large precipitation events recorded by the equipment that did not actually occur. These events were not recorded by other regional weather stations and were not reflected in soil moisture response. This unknown equipment malfunction should be kept in mind for future anomalous data.

Despite several intense rainstorms during summer 2007 (Figure 11), the mulch stayed in place and did not show rilling or erosional features. In contrast, adjacent bare soil areas were significantly impacted by the intense storms. The mulch encouraged revegetation and treated areas were equal in cover to untreated areas.
